17.0 Slick Rock, Colorado, Disposal Site

17.1 Compliance Summary

The Slick Rock, Colorado, Uranium Mill Tailings Radiation Control Act (UMTRCA) Title I Disposal Site was inspected on May 5, 2008. The disposal cell and its associated surface water drainage features remain in good condition and are functioning as designed. Minor erosion, exacerbated by several large runoff events during the last 2 years, was still evident at the site; however, it does not threaten the disposal cell or site features. The culvert at the entrance gate, which showed increasing signs of erosion, was replaced with a larger-diameter culvert. Large gullies containing deep headcuts that had formed between the retention pond and the county access road were also repaired. Noxious weeds were re-treated with herbicide; these continued weed control efforts have significantly reduced infestations on the site. No other maintenance needs or cause for a follow-up or contingency inspection was identified.

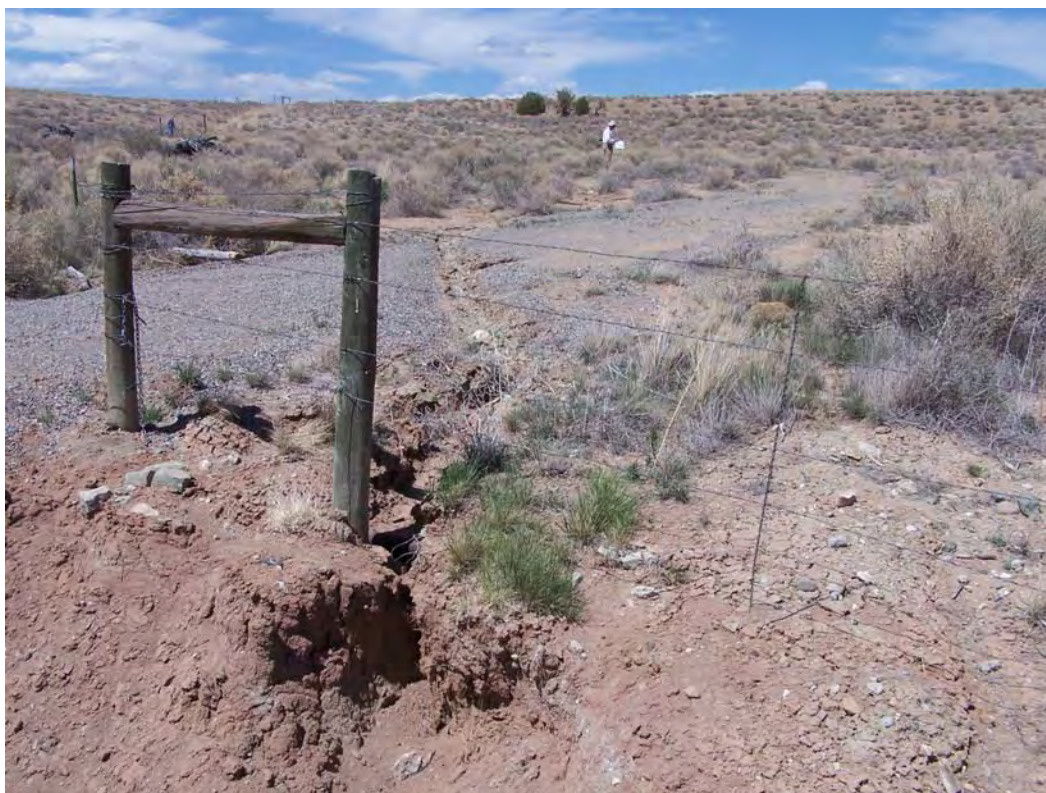
17A **Access Road, Gate, Fence, and Signs**—Access to the site is off County Road T11, an improved gravel-and-dirt road maintained by San Miguel County. The road was in good condition at the time of the inspection, although minor erosion had occurred across the road just inside the entrance gate (PL–1). Since 2006, inspectors have noted that the 8-inch-diameter culvert, installed beneath the access road in 2004 to allow runoff to flow along the borrow ditch, was being continually eroded by stormwater runoff. In May 2008, inspectors noted that additional erosion was evident at both ends of the culvert (PL–2). Additionally, tumbleweeds (noted in the 2007 inspection) were still accumulating in the inlet to the culvert. As it was apparent that the culvert’s small diameter could not adequately handle storm runoff, the culvert was replaced with a 15-inch-diameter culvert in July 2008 (PL–3), and tumbleweeds present in the inlet were removed. The minor erosion across the access road was also repaired.

SRK 5/2008. PL-1. Gully across access road just inside entrance gate; repaired in July 2008.

In 2008, for erosion control purposes, DOE replaced the 8-inch-diameter culvert at the entrance gate near the country road with a 15-inch-diameter culvert. Minor erosion across the access road just inside the entrance gate was also repaired. Two large gullies containing deep headcuts that had formed southwest of the retention pond were repaired. As part of an ongoing weed maintenance program, several areas where noxious weeds were noted were re-treated with herbicide.

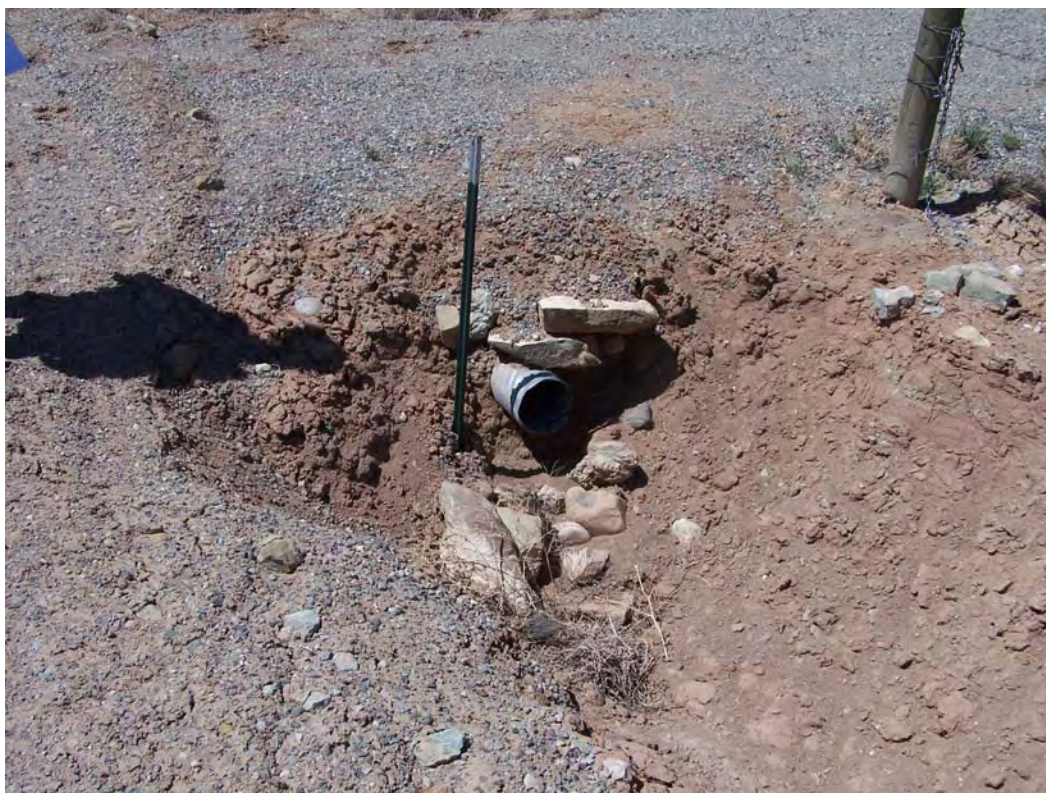
SRK 5/2008. PL-2. View of outlet with eroded 8-inch-diameter culvert (May 2008).

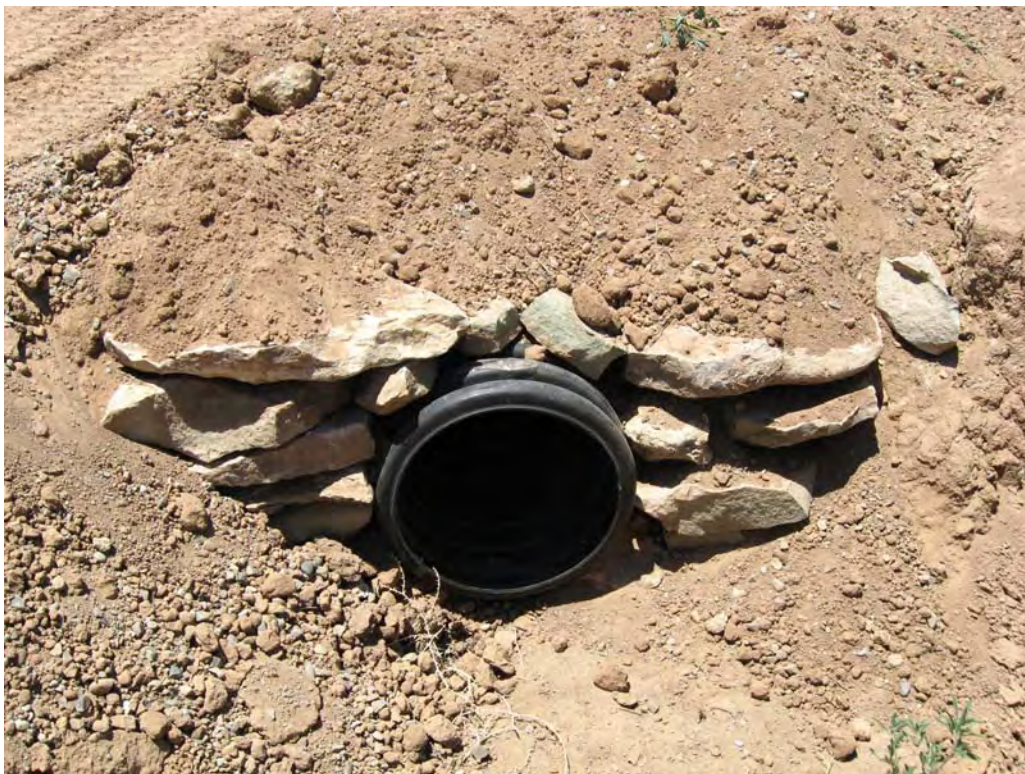
SRK 7/2008. PL-3. Outlet of newly installed 15-inch-diameter replacement culvert (July 2008).

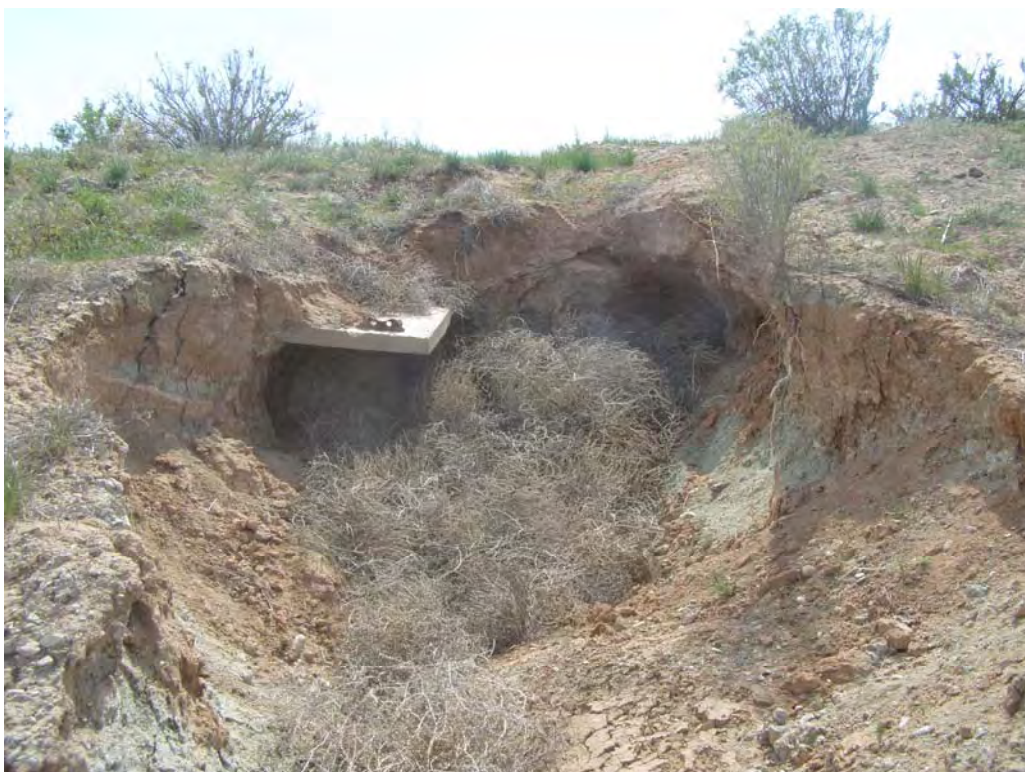
17B Areas of erosion between the apron and the retention pond were repaired in 2004. Although the area downslope of the apron is stabilizing, some erosion is still occurring. Several large storm runoff events during the last 2 years had increased the size of gullies southwest and northwest of the retention pond. The largest gully, located southwest of the retention pond below the culvert outlet on the county road, was 10 feet wide by 35 feet in length, with a 7-foot-deep vertical headcut, at the time of the inspection (PL-4). A second gully, located a short distance to the southeast and characterized by a 3-foot vertical headcut, had not increased in size since 2007 but was still in need of repair. Both of these headcuts were repaired in July 2008 (PL-5). Gullies previously noted on the northwest side of the retention pond are still as deep as 30 inches, but they do not present a hazard to the disposal cell or to any site feature. As such, action is still not warranted at this time. All of the aforementioned erosion areas will continue to be monitored as part of future inspections.

SRK 5/2008. PL-4. Primary gully below county road with 7-foot-deep vertical headcut, repaired in July 2008.

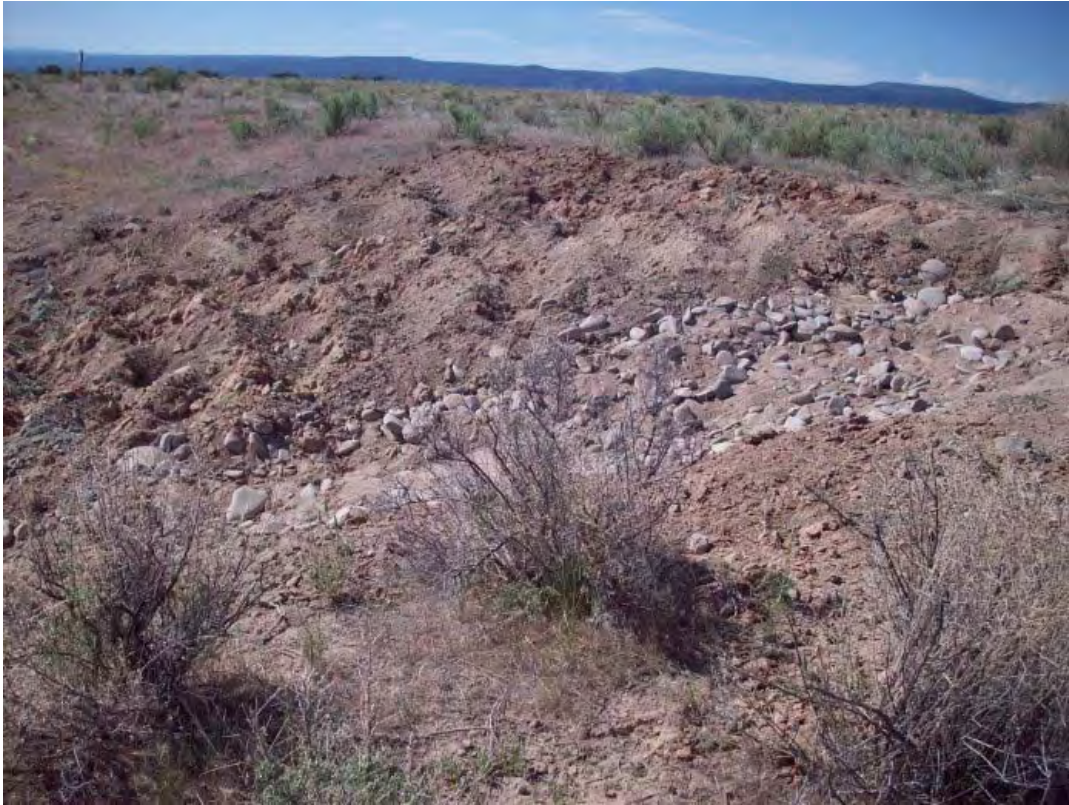
SRK 7/2008. PL-5. July 2008 erosion repair of primary gully.

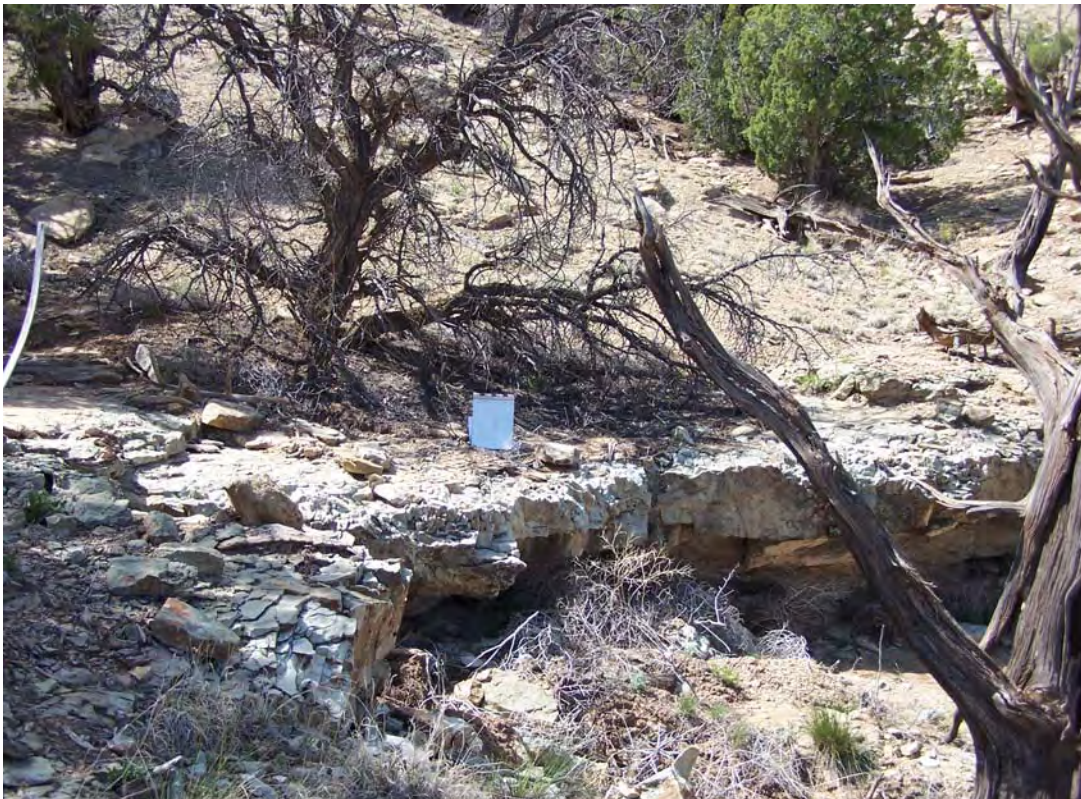
The Kd-1 (Dakota) sandstone unit, which crops out near the northeast corner of the property, was identified in the LTSP as a potential pathway of lateral migration of transient drainage from the disposal cell. In 2007, inspectors noted that minor erosion of the surface had taken place along the outcrop; however, there was no evidence of moist soil, mineralization, or phreatophyte vegetation that would indicate that transient drainage is occurring along this interface. The latter was still the case at the time of the 2008 inspection (PL-6).

SRK 5/2008. PL-6. Kd-1 (Dakota) sandstone outcrop.
